CORNER RECORD

Agency Index CR-24-226
Document Number _____

City of STOCKTON County of SAN JOAQUIN, California

Brief Legal Description PORTION OF SECTION 4 TOWNSHIP 1 NORTH RANGE 6 EAST.

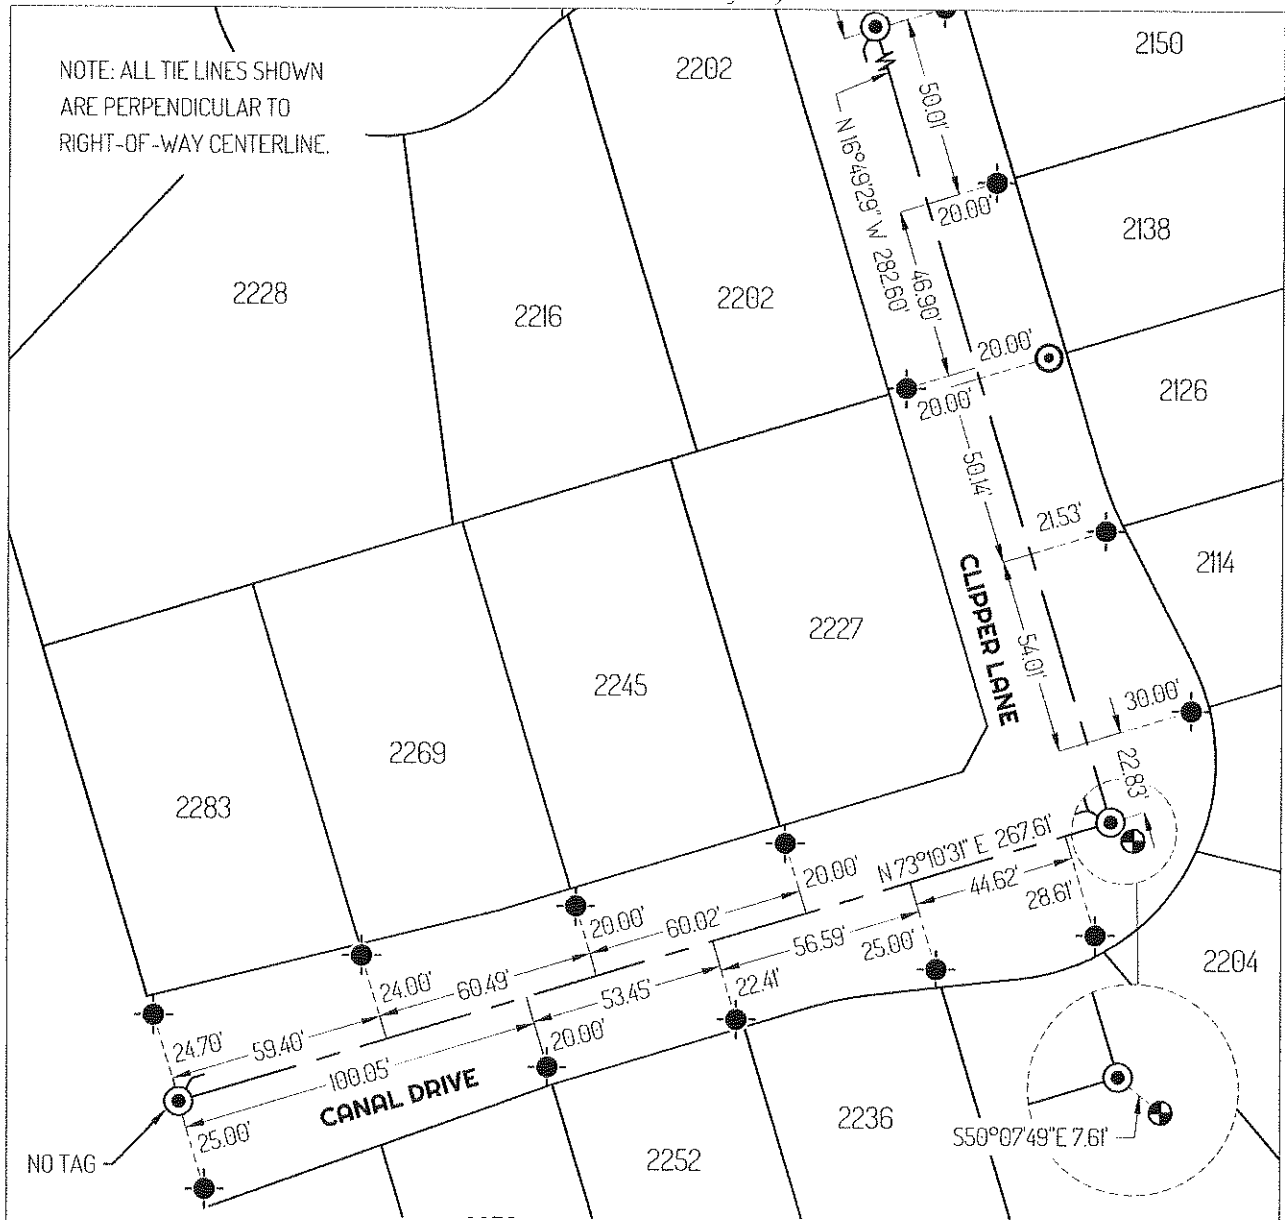
NOTE: ALL TIE LINES SHOWN ARE PERPENDICULAR TO RIGHT-OF-WAY CENTERLINE.

- FOUND CHISELED CROSS ON SIDEWALK SET AS 5 FOOT WITNESS CORNER UNDISTURBED PER (A)
- MONUMENT DESTROYED AND RESET WITH BRASS PLUG TAGGED "LS 8489"
- FOUND CENTERLINE MONUMENT IN WELL UNDISTURBED PER (A)
- FOUND PAVEMENT NAIL UNDISTURBED PER (A)
- 435 REFERENCE STREET ADDRESS
