Agency Index R-24-3 **CORNER RECORD** Document Number Stockton County of San Joaquin Brief Legal Description Lots 100, 101, 102, 103, 104, 105, M.&P. 23-30 CORNER TYPE COORDINATES (Optional) N. E. Government Corner Control Elevation X Property Meander Units Metric U.S. Survey Foot Rancho Other Horizontal Datum Zone Epoch Date Date of Survey September 9, 2024 Vertical Datum Complies with Public Resources Code §§8801-8819 Complies with Public Resources Code §§8890-8902 8765(d) 8771 PLS Act Ref.: 8773 Other:

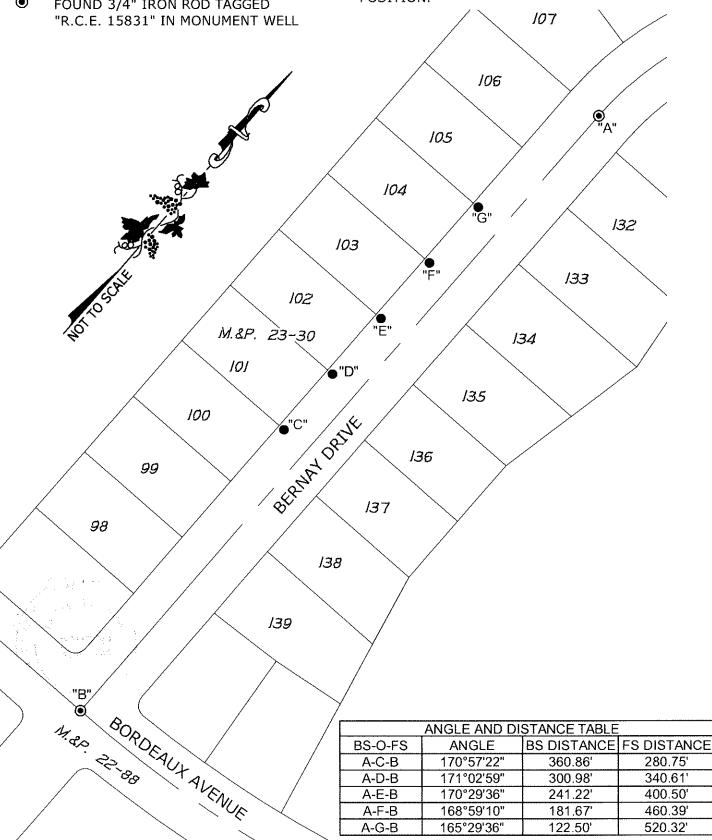
FOUND CHISELED CROSS

• FOUND 3/4" IRON ROD TAGGED DESCRIPTION:

THIS CORNER RECORD IS FOR THE PURPOSE OF MONUMENT PRESERVATION. REFERENCES WERE SET FOR FOUND MONUMENTS AS NOTED ON DIAGRAM. NO BOUNDARY ANALYSIS WAS PERFORMED. THIS CORNER RECORD DOES NOT VERIFY THE MONUMENT(S) TO BE IN THE CORRECT POSITION.
