CORNER RECORD

Agency Index CR-25-041
 Document Number _____

City of Stockton County of San Joaquin, California
 Brief Legal Description Lots 552, 571, 572, 573, M&P 24-59

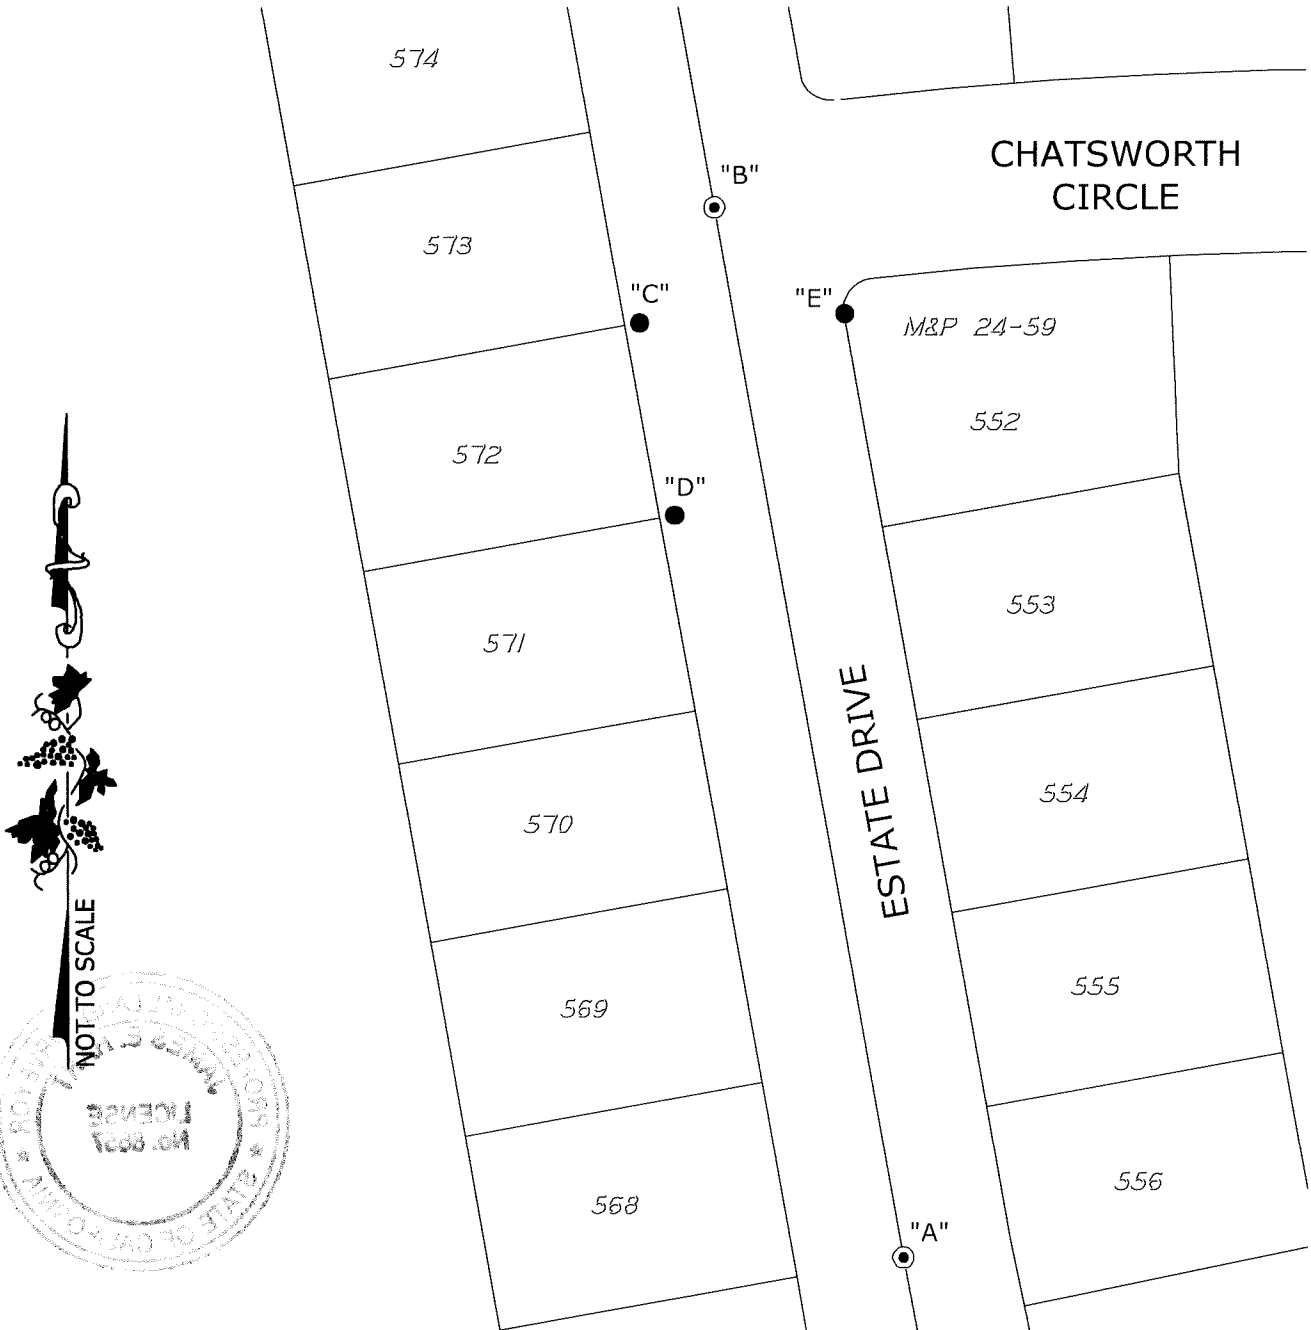
- FOUND 3/4" IRON PIN TAGGED "R.C.E. 15831" IN MONUMENT BOX
- FOUND CHISELED CROSS

THIS CORNER RECORD IS FOR THE PURPOSE OF MONUMENT PRESERVATION. REFERENCES WERE FOUND AND/OR SET FOR FOUND MONUMENTS AS NOTED ON DIAGRAM. NO BOUNDARY ANALYSIS WAS PERFORMED. THIS CORNER RECORD DOES NOT VERIFY THE MONUMENT(S) TO BE IN THE CORRECT POSITION.

ANGLE AND DISTANCE TABLE			
BS-O-FS	ANGLE	BS DISTANCE	FS DISTANCE
A-C-B	131°27'50"	321.51'	45.42'
A-D-B	155°34'36"	256.92'	102.94'
A-E-B	132°41'15"	313.12'	55.65'
